# Corrosion and scaling studies – project results and lessons learned

Dagur Ingi Ólafsson, IceTec, [dagur@taeknisetur.is](mailto:dagur@taeknisetur.is)

28.01.2022, Online

Within the **MEET project** a significant part of the research work performed was the conduction and subsequent analysis of various in-situ corrosion and scaling tests performed to find a suitable material choice for heat exchangers used in the Organic Rankine Cycle power plants developed in the project as well as to evaluate brine transport solutions:

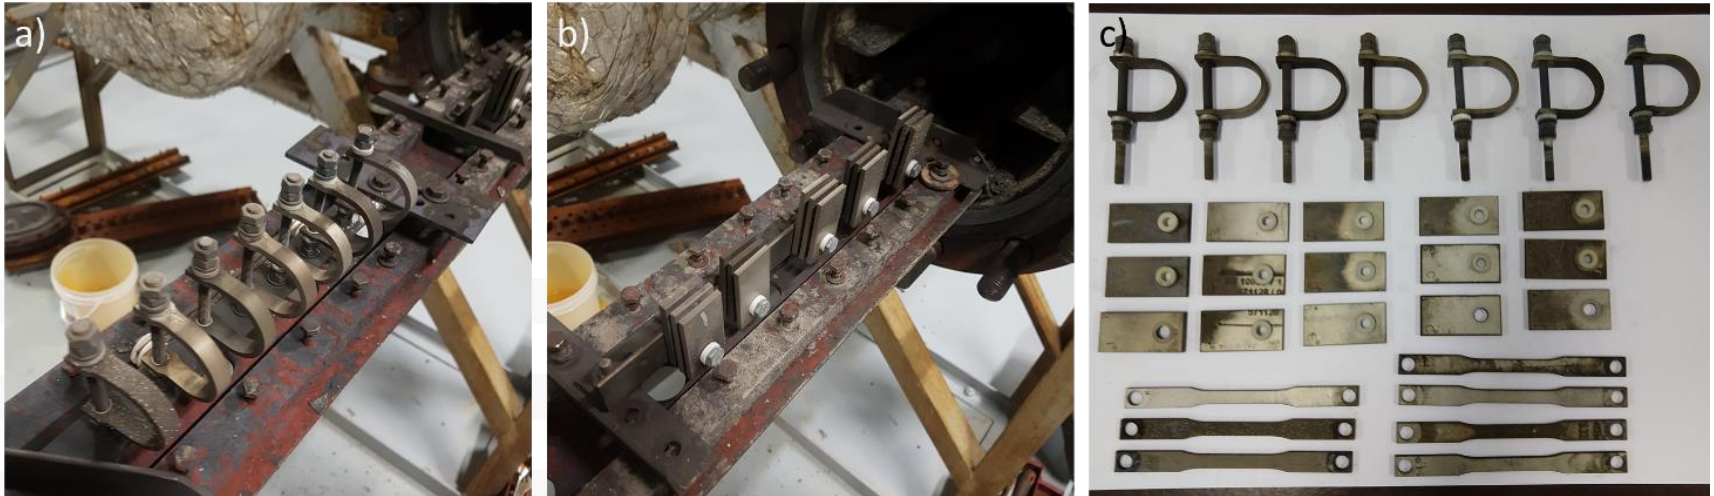
The samples from the Reykjanes testing; a) the U-bend samples, b) the rest of the samples and c) all the samples after they were removed from the holders.

At Reykjanes, all metal material candidates were tested in a geothermal steam at 200 °C and 18 Bar for 1 month, in a special testing pressure vessel operated at the Reykjanes power plant by HS Orka.

Material	Pits	Cracks	Wide slanting pits/cracks	Inclusions	Voids	Inclusions/voids in horizontal formation
316L	xxx	x	n/a	x	x	x
2205	xx	x	x	x	x	n/a
904L	x	n/a	xx	x	x	xx
2507	xx	xx	x	x	x	x
Alloy 625	(x)	xx	xx	xx	x	x
254 SMO	x	x	x	x	x	xx
Ti Gr.2	x	n/a	n/a	n/a	n/a	n/a

Corrosion effects and defects in the materials after testing at Reykjanes.

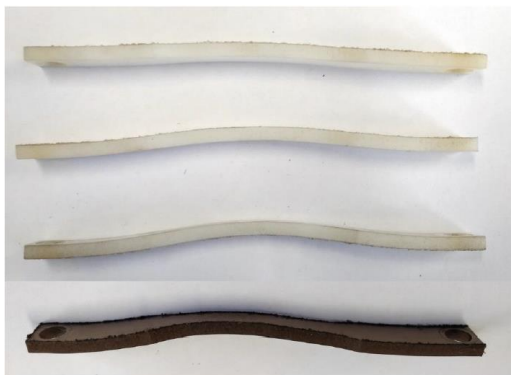
Warping of plastic samples after testing.

PVF was an initial material candidate as plastic heat exchangers are often used in severely corrosive conditions. However, due to warping, the plastic material was discarded as a potential candidate.

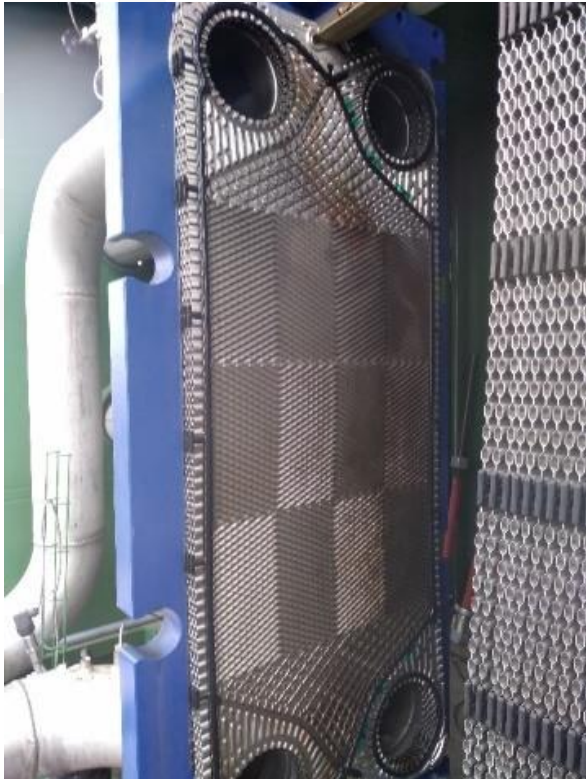
Three plates were removed from the ORC heat exchanger at Grásteinn and analysed macro- and microscopically.

Dismantling of heat exchanger.

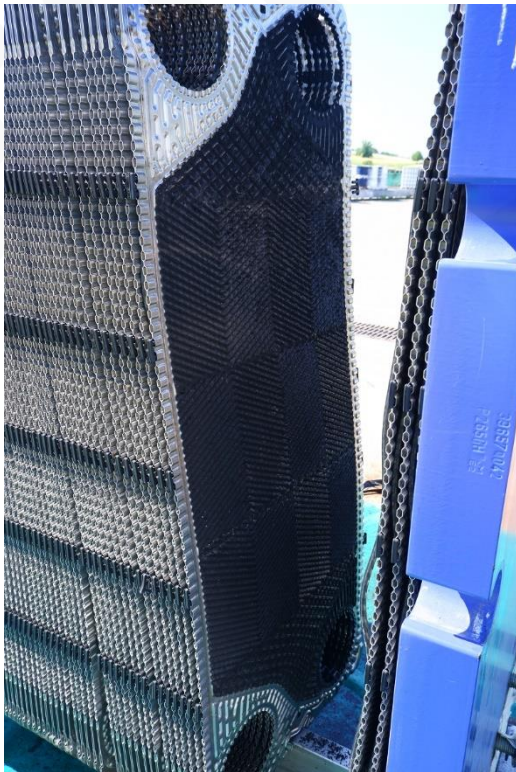
Three plates were removed from the ORC heat exchanger at Soultz and analysed.

Dismantling of heat exchanger.
